Final Report
MINE SAFETY EVALUATION
FOR
PROJECT RULISON

By R. L. Bolmer

U. S. Bureau of Mines
Denver Mining Research Center
Denver, Colorado

January 10, 1970

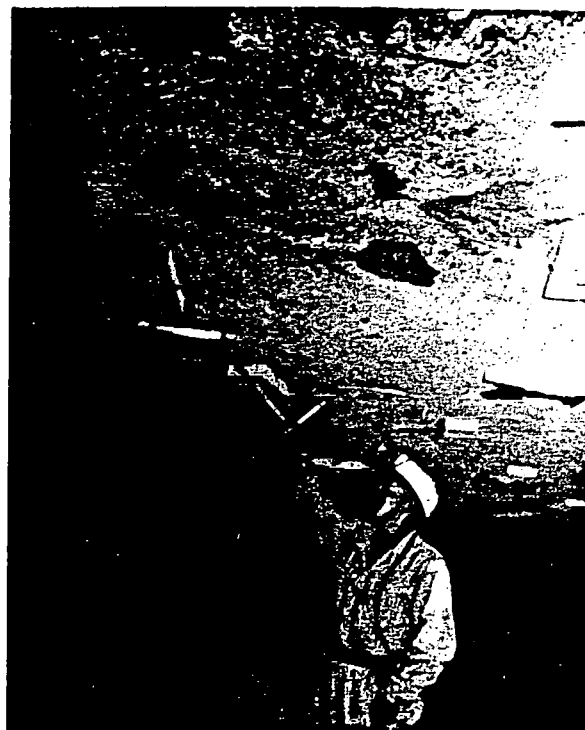
Fig. 3 - New crack in caprock
($\frac{1}{2}$ inch wide by 40
feet long) of No. 1
Southwest entry out-
by No. 1 Outside entry.

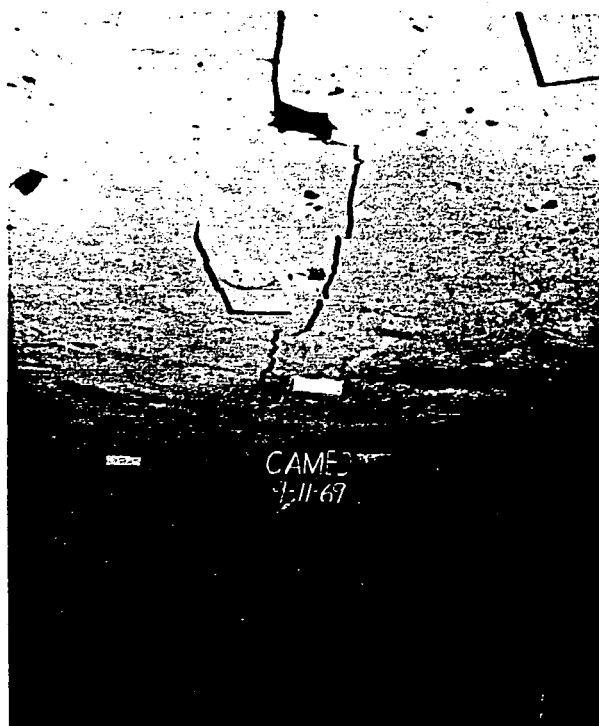
Fig. 5 - New crack in caprock
(3/8 to 1/2 inch wide)
along No. 2 Outside entry
between 1st and 2nd
Intersections.

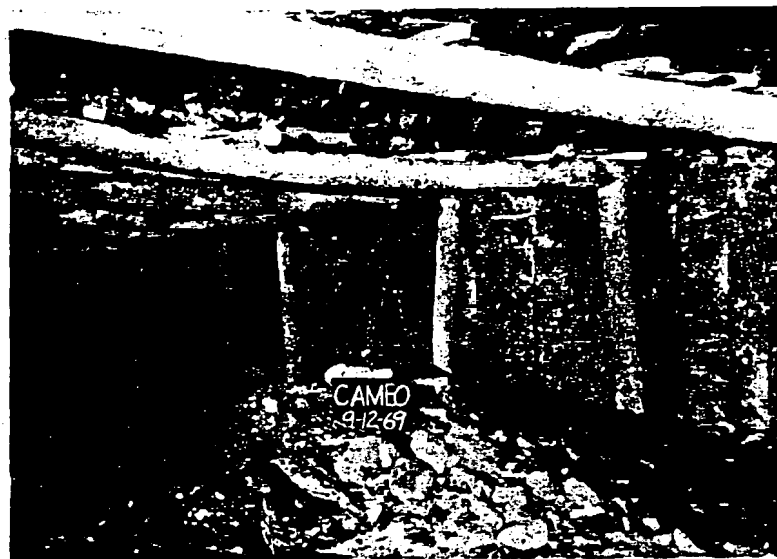
Most of the structural damage disclosed by the post-shot inspection and attributed to the Rulison event, was confined to working areas under shallow cover, close to the outcrop -- specifically the 1st Southwest section and the Nos. 1 and 2 Outside entries. In these areas of poor to bad roof, new cracks in the caprock were formed, and some of the old existing cracks were enlarged. (See figures 2 to 5.) A small roof fall also occurred along one entry, and the resulting separation of the roof strata adjacent to this fall placed excessive weight on several successive timber sets in the entry. (See figures 6 and 7.)

Fig. 7 - Roof fall (+ 3 cubic yards) and sagging cross bar in No. 2 Outside entry, 40 feet outby face.

Necessary repairs to this section of the mine, as determined by the consultant engaged at the request of the operator, involved the removal of 4 damaged timber sets, the cleanup of some 9 cubic yards of fallen rock, and the installation of 25 new timber sets along 150 feet

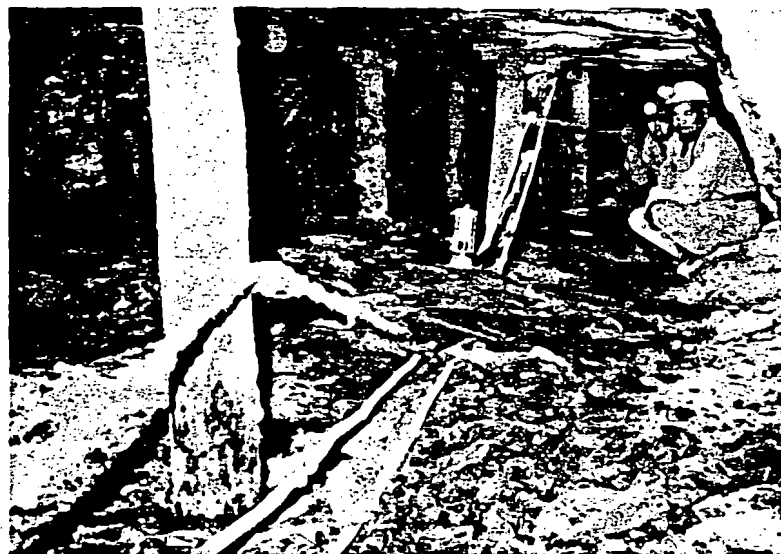
The special post-shot inspection of this mine revealed that an aggregate of about 1/2 cubic yard of the shale caprock had recently fallen from the roof in four isolated sections of the workings. (See figures 8 to 11.) The most serious fall occurred midway along the inclined return airway where a thin slab, about 4 feet by 2 1/2 feet in area, had dropped onto the electrical power cables serving the mine. In dropping, this slab tore loose the power cables from their insulated hangers on two adjoining timber props. The cleanup of all the recently fallen rock and the rehangng of the power cables were estimated to require about 1/2 man-shift at a cost of about \$25.

Fig. 8 - Thin slab of caprock down on power cables
in return airway just east of incline shaft.

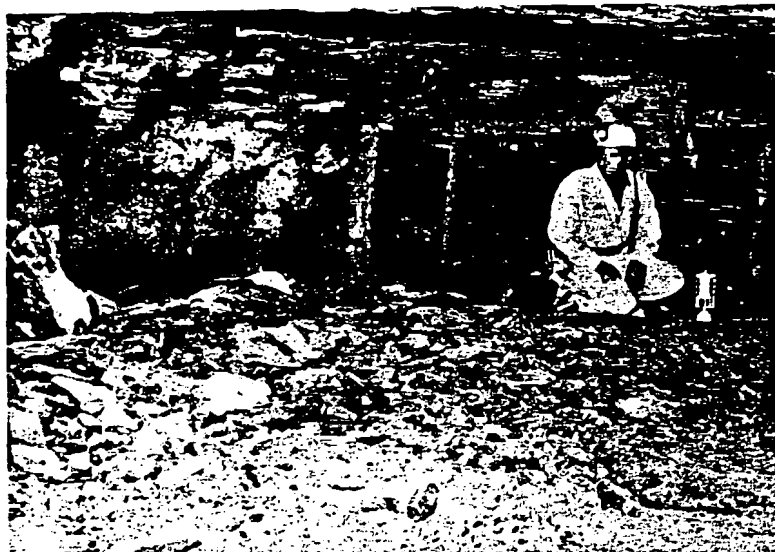
Fig. 9 - Caved caprock (darker material on top of old cave
and under lamp) in level entry just east of incline shaft.

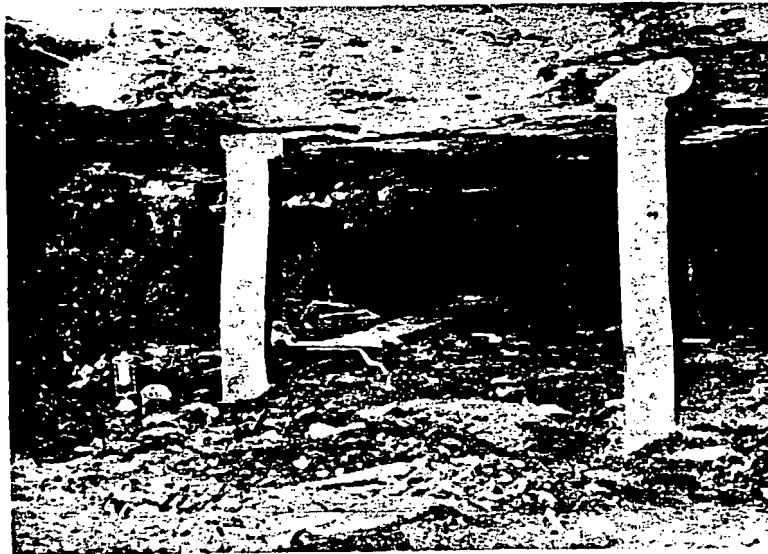
Fig. 10 - Caved caprock (by lamp and on shaker pan) in level entry east of incline shaft.

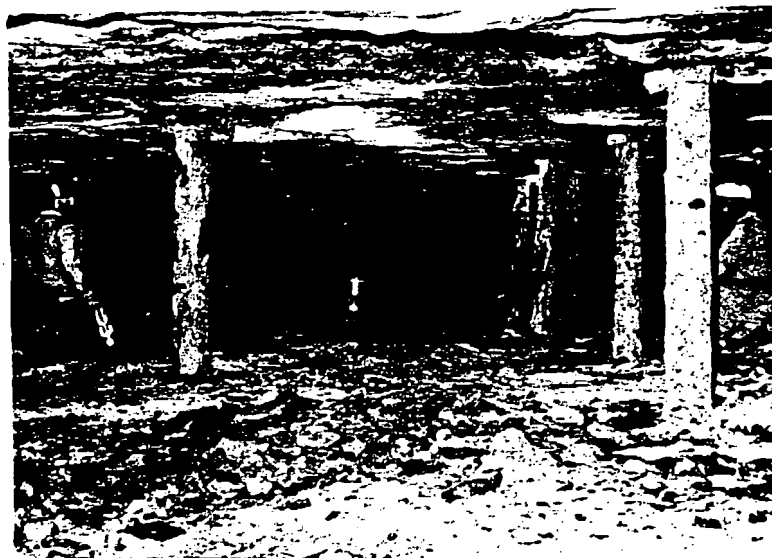
Fig. 11 - Caved caprock (darker material in foreground and below lamp) in old room driven up pitch from level entry east of inclined shaft.

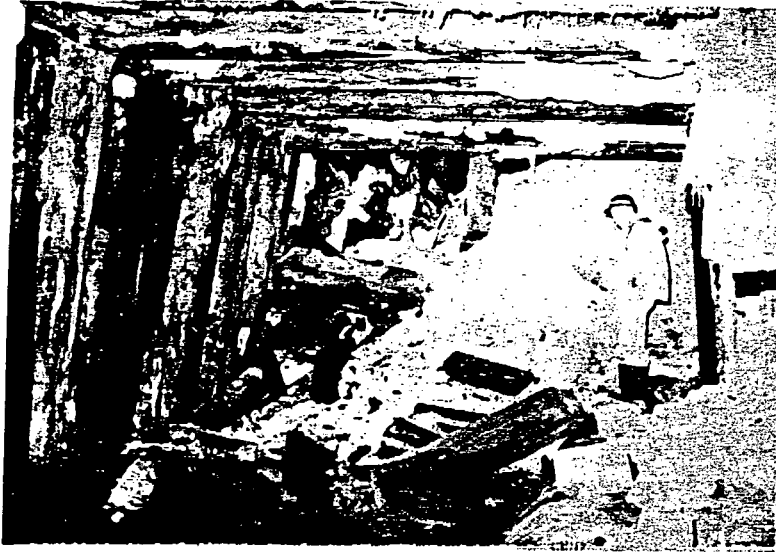
A major cave-in of about 130 cubic yards of rock and timber at 4,200 feet from the east portal, plus minor rock and timber falls at four other locations, was reported to have occurred sometime between September 9th and 15th. (See figures 12 to 14.) Investigations indicated that the major cave-in could have coincided with the Rulison event, but that the minor rock and timber falls may not have. No ground motion was felt in the immediate area, and such motion as could be projected for the area probably was too low to have caused the damage. Any consideration of the past history of the tunnel and its present physical condition leaves little doubt that the cave-in would have occurred sooner or later, irregardless of the Rulison event.

Fig. 12 - West end of major
cave-in at 4200 feet.

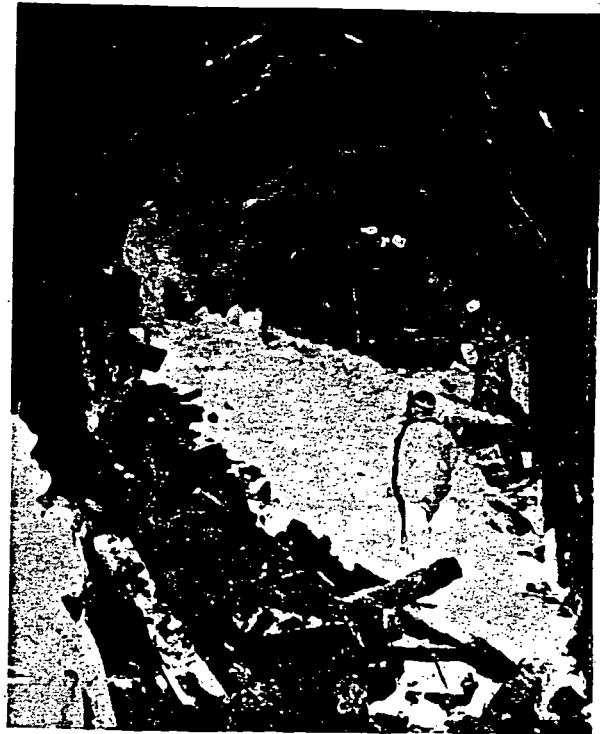
Fig. 13 - East end of major cave-in
at 4200 feet.

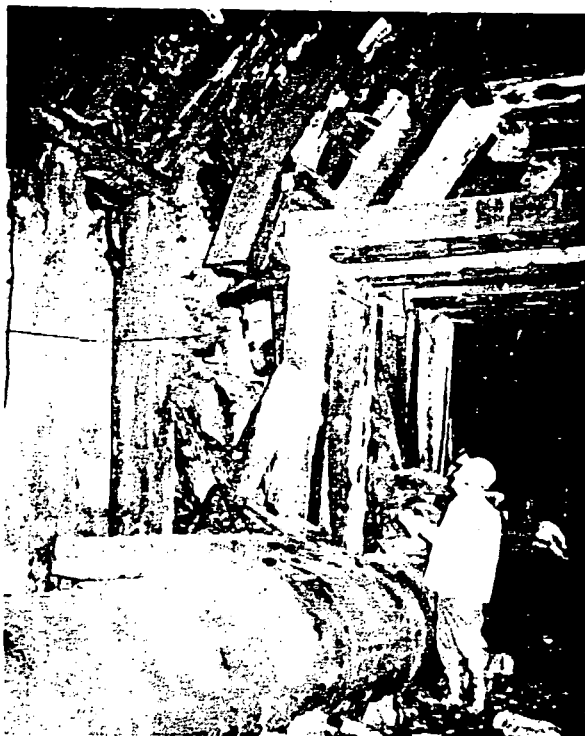
Fig. 14 - Disintegrated wall plate, toppled
post, and sagged arch segment of
old tunnel set at 4055 feet.

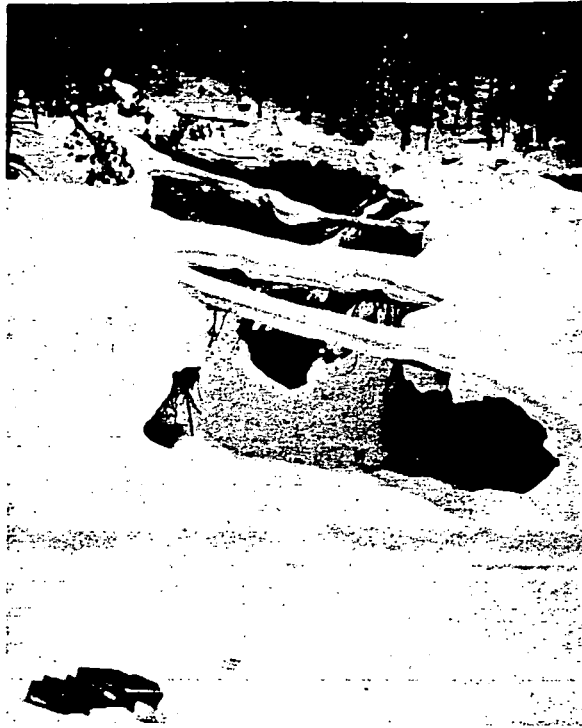
Carter mine Damages to the Carter and two other contiguous gold mines, consisting of caved adit portals in alluvium and caved drifts below old shrinkage stopes, also were reported as resulting from the Rulison event. (See figures 15 and 16.) An inspection revealed nothing conclusive that would tie this damage to Rulison. About all that could be determined was that it probably was of recent origin. The sections of the mines found damaged were those most susceptible to natural cave-ins. Considering the age of the workings, the conditions of the old timbers, and the altered nature of the Precambrian granite and schist wall rock, such cave-ins would be expected to occur periodically at any time. It was concluded that the damages reported were of natural origin and not related to the Rulison event.

Fig. 15 - Caved portal of No. 2
level of Golden Islet
mine.

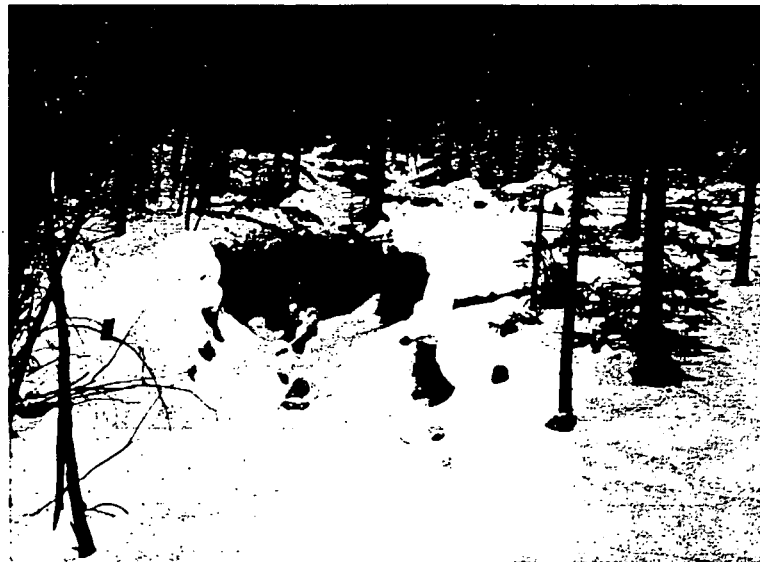
Fig. 16 - Caved portal of No. 3 level of
Golden Islet mine.

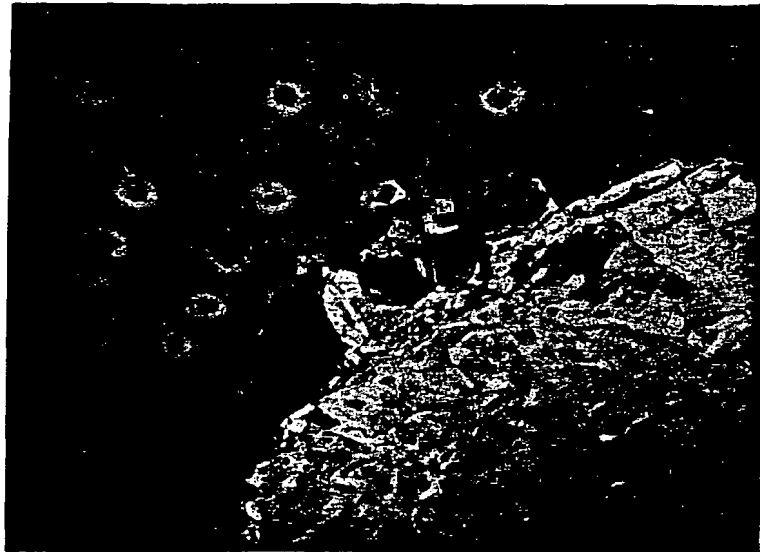
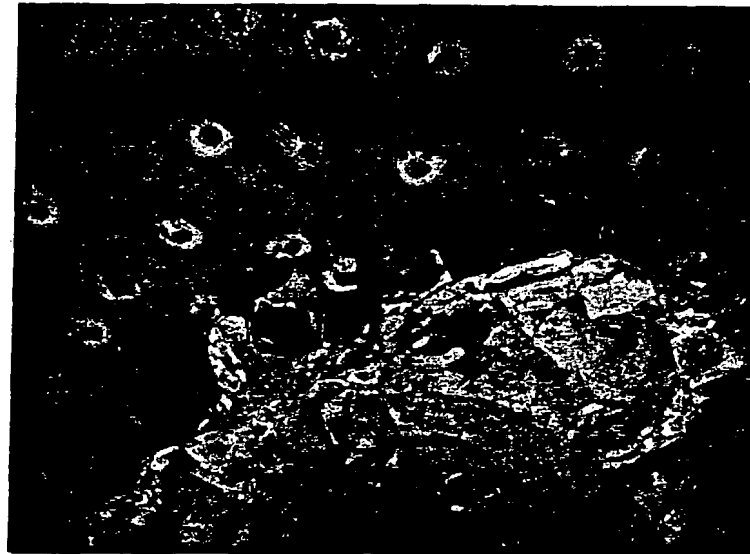
Rocks hanging from roof bolts at
edge of second major roof-fall area

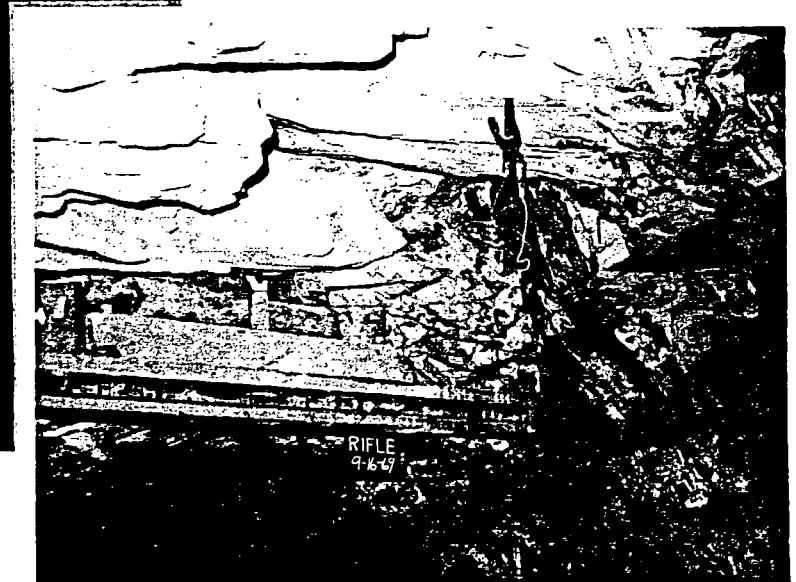
Fractured sandstone above timber set on A level, outby 54 draw

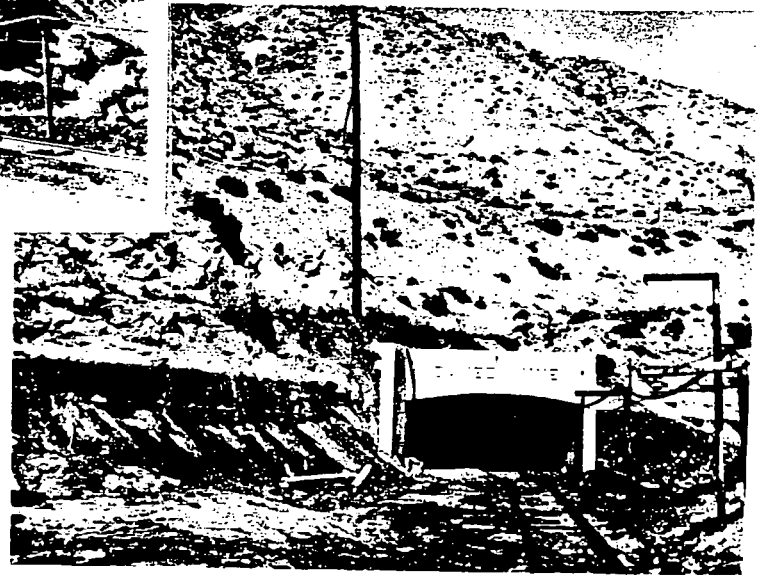
Caved cap rock around
roof bolts in No. 11
room, 2nd East, at
breaker row

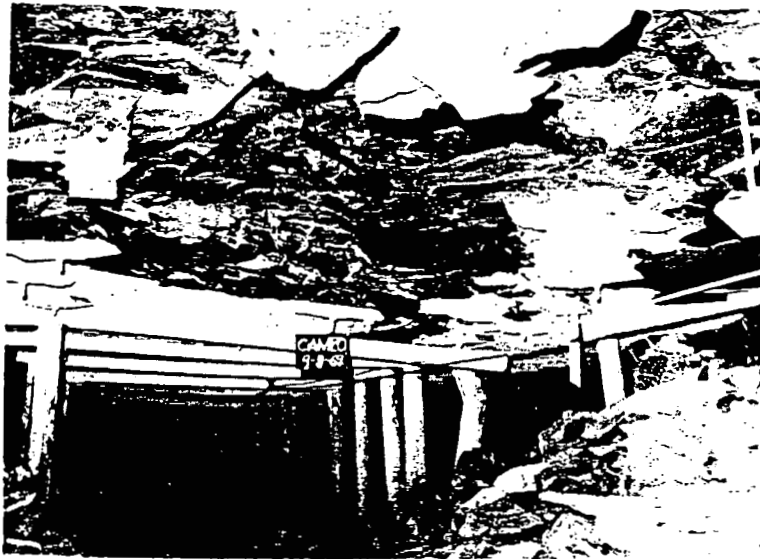
Caved roof of 3rd West
haulage entry

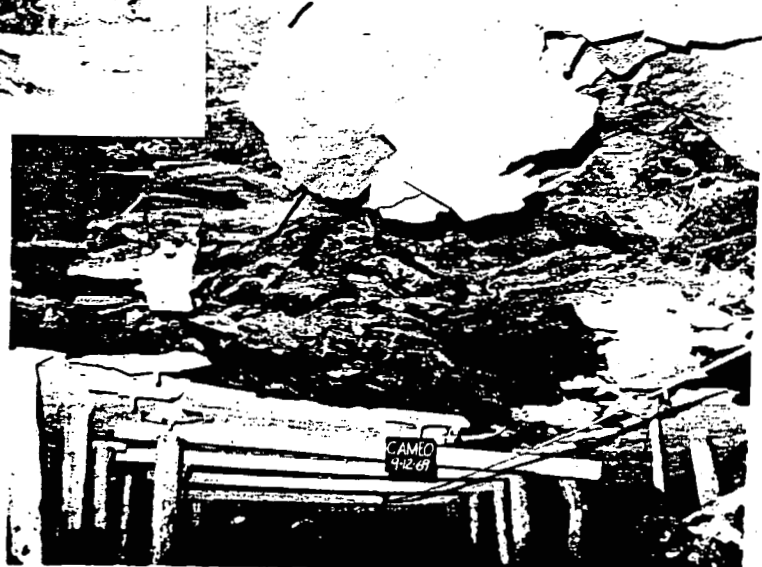
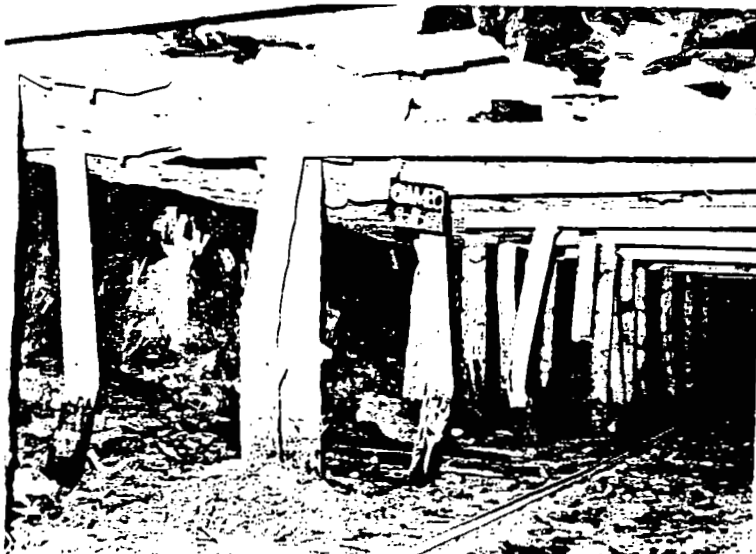
Timbers taking weight of
roof sag and floor heave
in 3rd West haulage entry

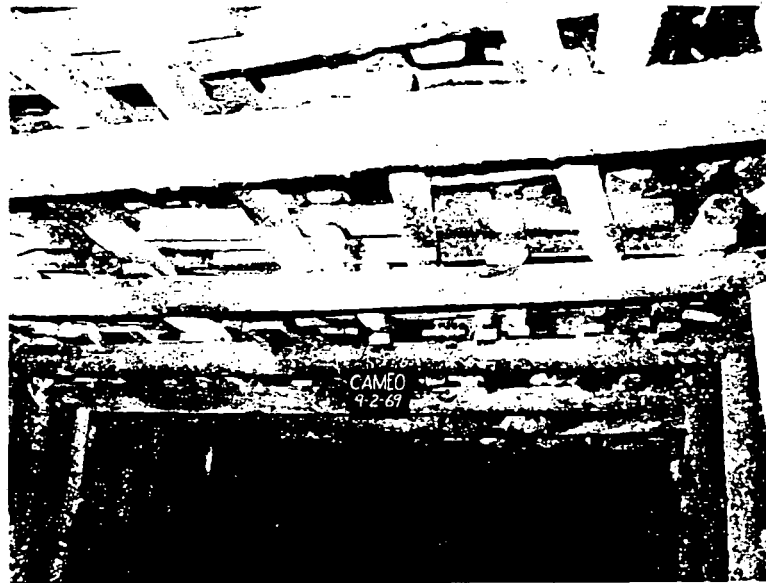
Timber crib in caved section of
surface alluvium in No. 2 Outside entry

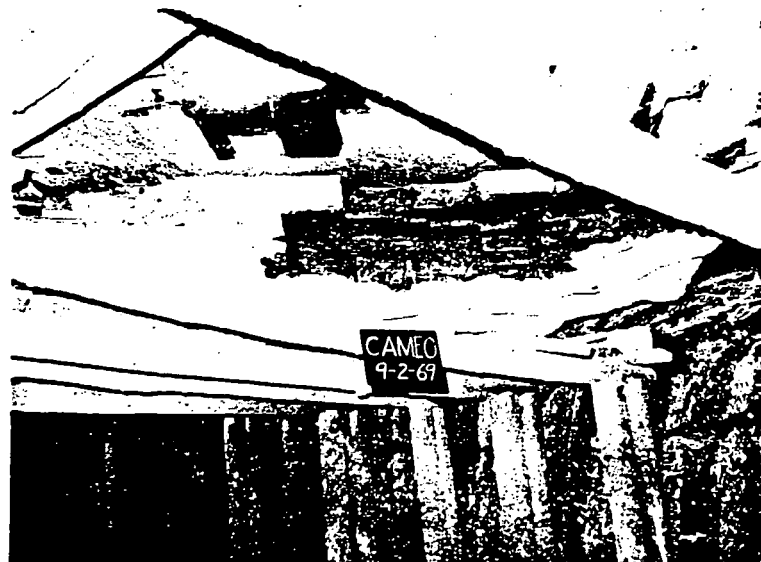
Cap rock and top coal separation above
timber supports in No. 1 Southwest entry

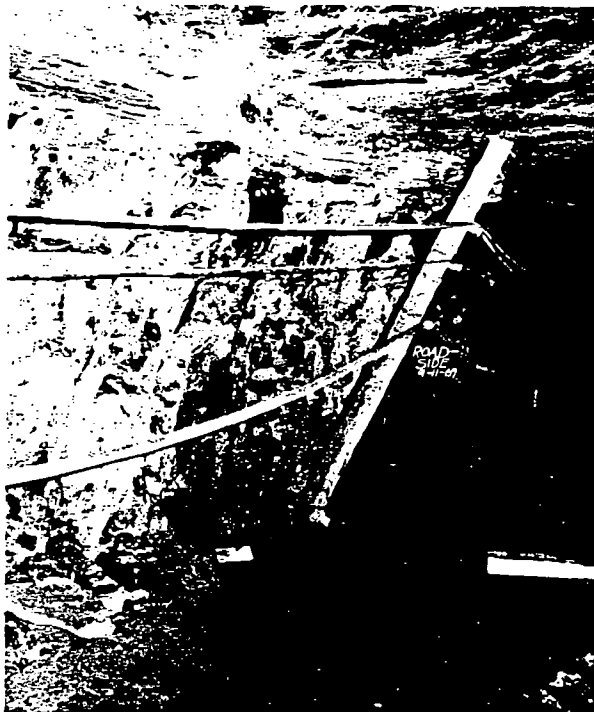
Topped post and fallen
cap piece in main
haulage entry - 9/11/69

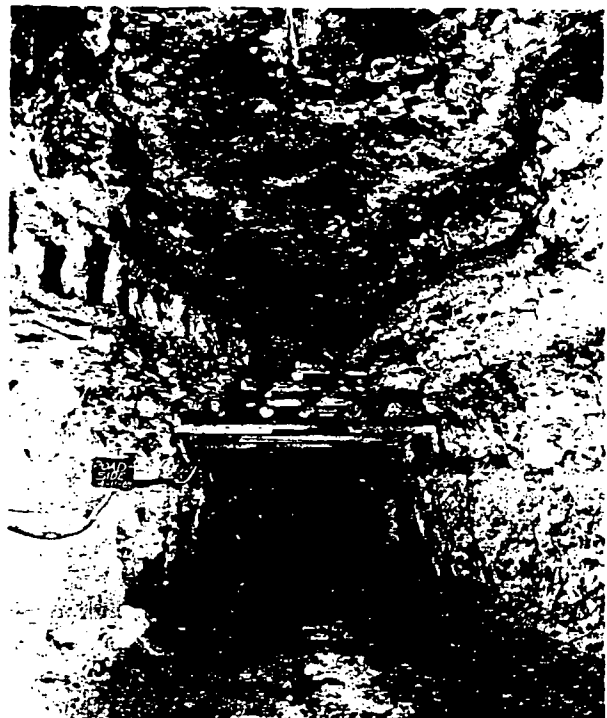
Caved section of main haulage entry
